Manhole Inspection Summary

Manhole # S25GG_057MH

Insp Date: **9/10/07 11:47 AM**

Location Address: **537 MISSION CT**

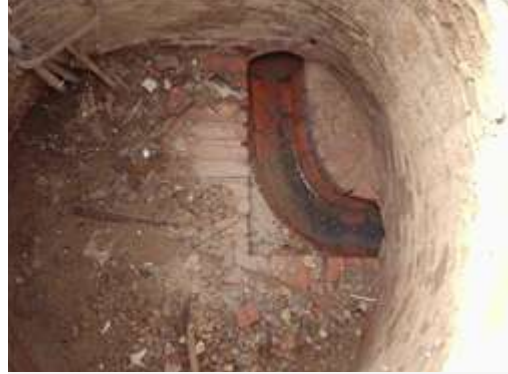
Top View

Corroded steps. Bench debris.

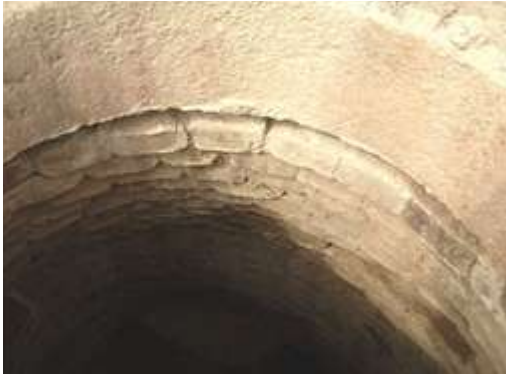
Defect

Frame leaks. Adjustment deterioration, loose brick and infiltration. Barrel infiltration.

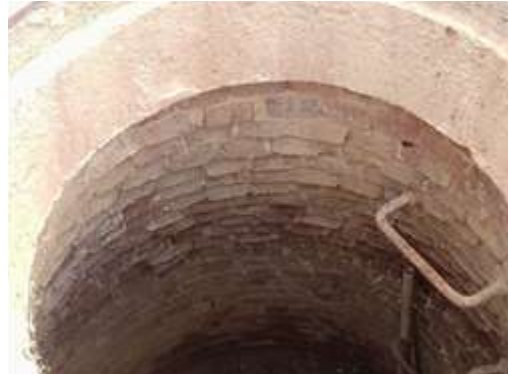
Defect

Frame leaks. Adjustment and Barrel infiltration.

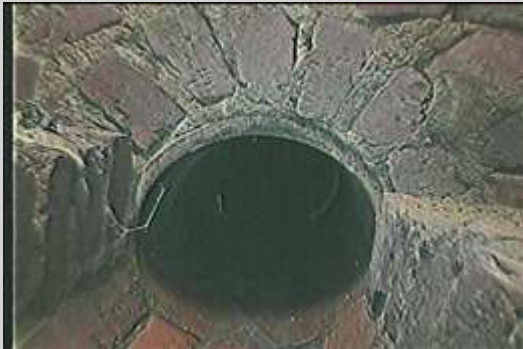
8 in. Circular Gravity Sewer Pipe Out @ 12 O'Clock

Invert Depth: **7.10** (ft.) Flow Characteristics: **Slow**

Deposits: ☒ None ☐ Mud ☐ Sludge ☐ Debris ☐ Grease

Infiltration: **None** Pipe Seal Cond: **Unknown**

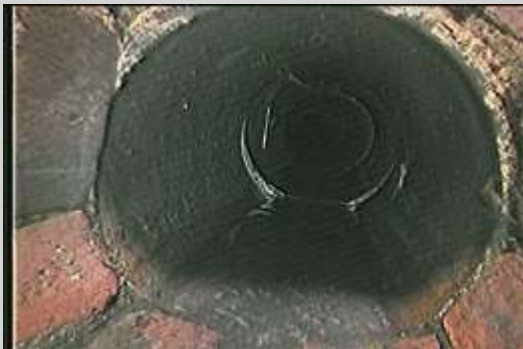
8 in. Circular Gravity Sewer Pipe In @ 3 O'Clock

Deposits: ☐ None ☒ **Mud** ☐ Sludge ☒ **Debris** ☐ Grease

Silt Depth: **0** (in.) Deposits Extent: **Light**

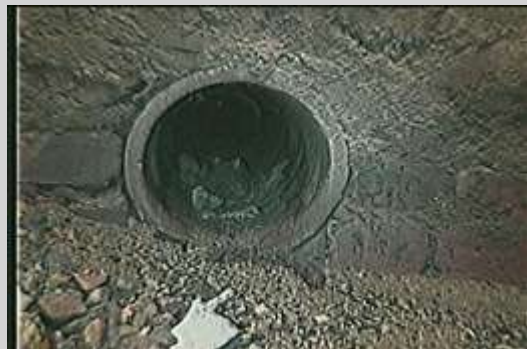
6 in. Circular Gravity Sewer

Invert Depth: **6.10** (ft.) Flow Characteristics: **None**

Deposits: ☒ None ☐ Mud ☐ Sludge ☐ Debris ☐ Grease

Infiltration: **None**
